Journal of the KwaZulu-Natal Institute for Architecture

# Aspects of Heritage Conservation

# Aspects of Heritage Conservation in KwaZulu-Natal

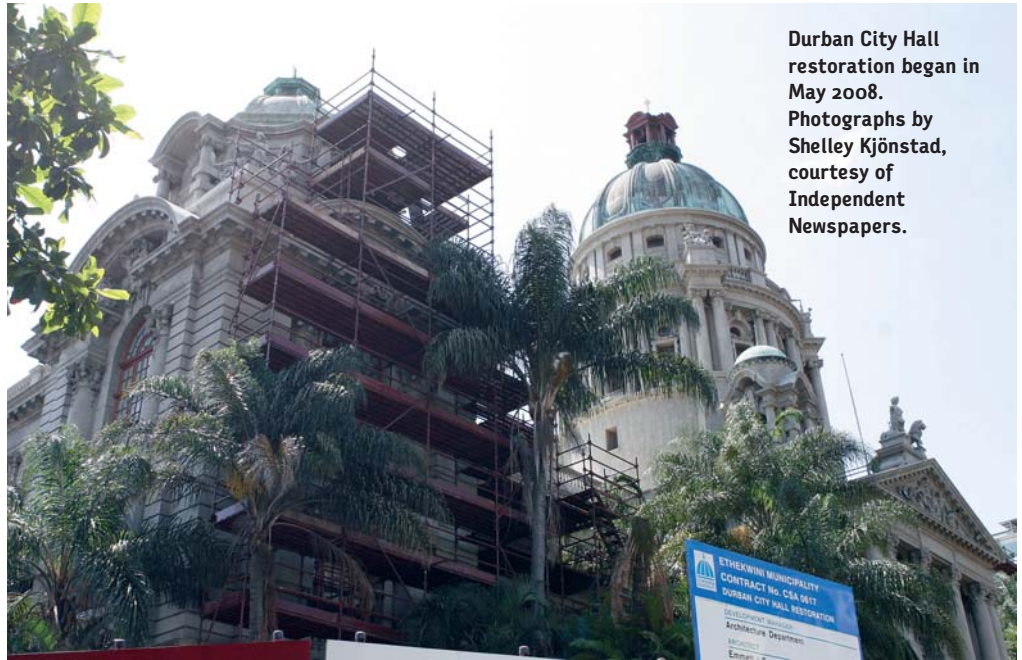
Durban City Hall restoration began in May 2008. Photographs by Shelley Kjönstad, courtesy of Independent Newspapers.

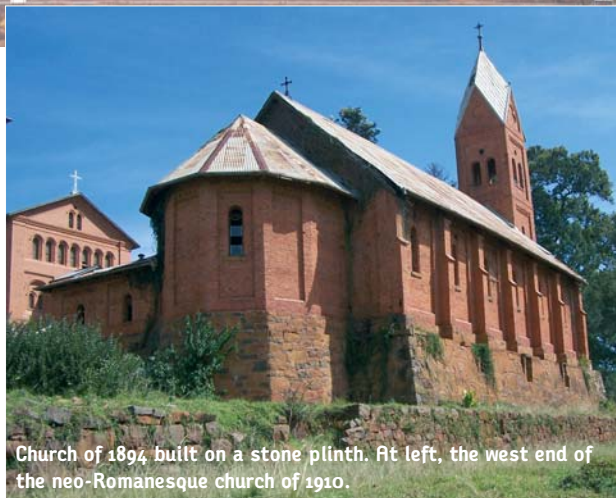
Church of 1894 built on a stone plinth. At left, the west end of the neo-Romanesque church of 1910.

1. the stabilisation of a historically important element in the mission environment; and
2. the retention of as much historical fabric as possible, while taking judicious decisions as to where to make structural interventions to provide necessary stabilisation. Beyond that there were the normal tasks of repairing, replacing and restoring decayed fabric.

To achieve the required stabilisation of the remaining building it has proved necessary to carefully dismantle about one-third of the nave wall and the ground and first floors to insert foundations under these elements as well as the splicing in of missing timber into the termite infested rafters, the repainting of various types of brickwork and stonework, and the re-galvanising of the original corrugated iron roof sheets and re-affixing them in their original positions. Finally there was the usual planning and integration of modern services necessary for a museologically sound environment in a historic building in a rural location.

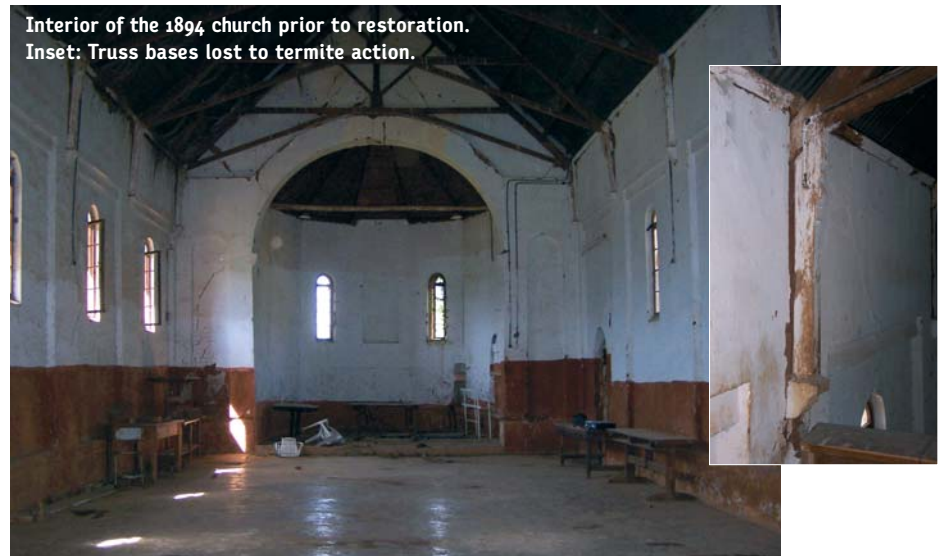
Interior of the 1894 church prior to restoration. Inset: Truss bases lost to termite action.

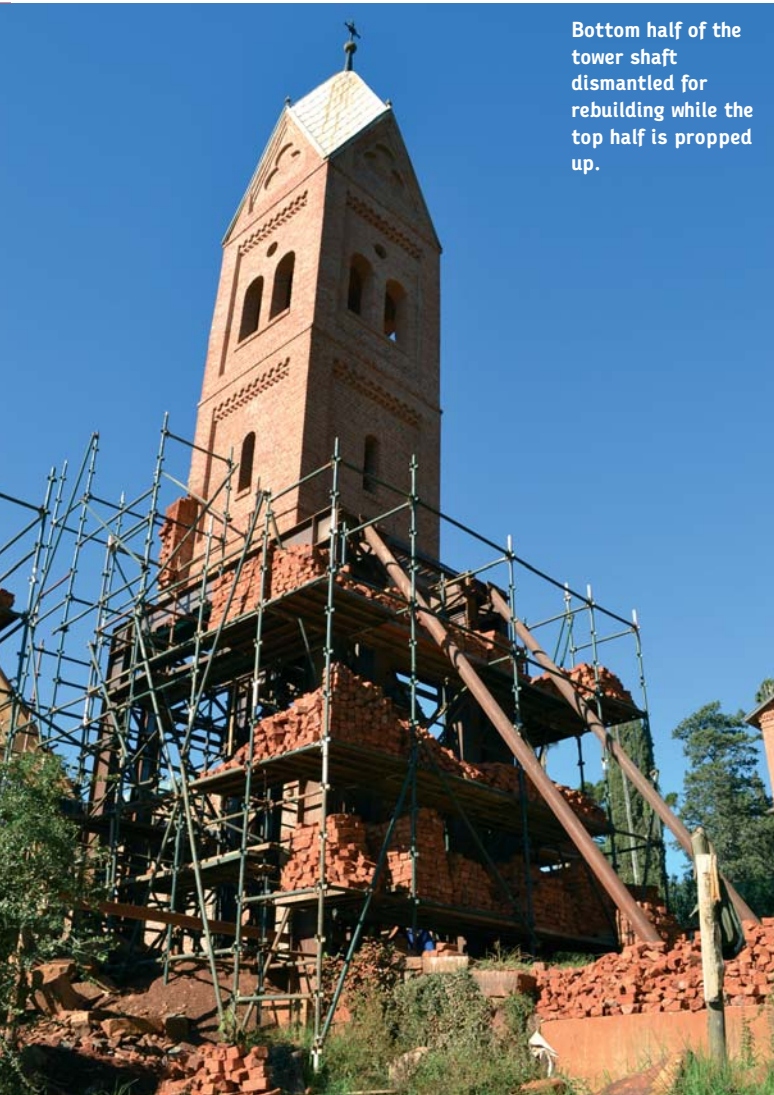
Bottom half of the tower shaft dismantled for rebuilding while the top half is propped up.

Possibly one of the most exciting and dramatic aspects of the restoration of the church has been the tower. The tower was leaning and it was discovered there were no foundations. From a practical perspective, the required construction

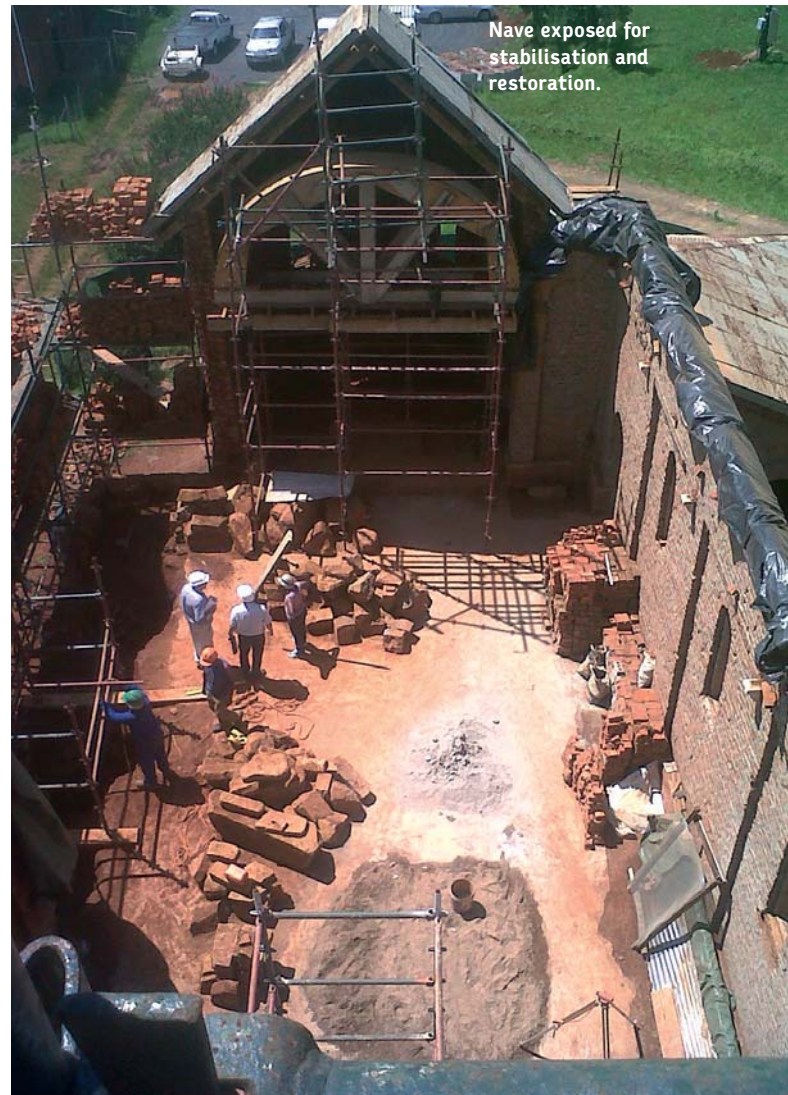
Nave exposed for stabilisation and restoration.

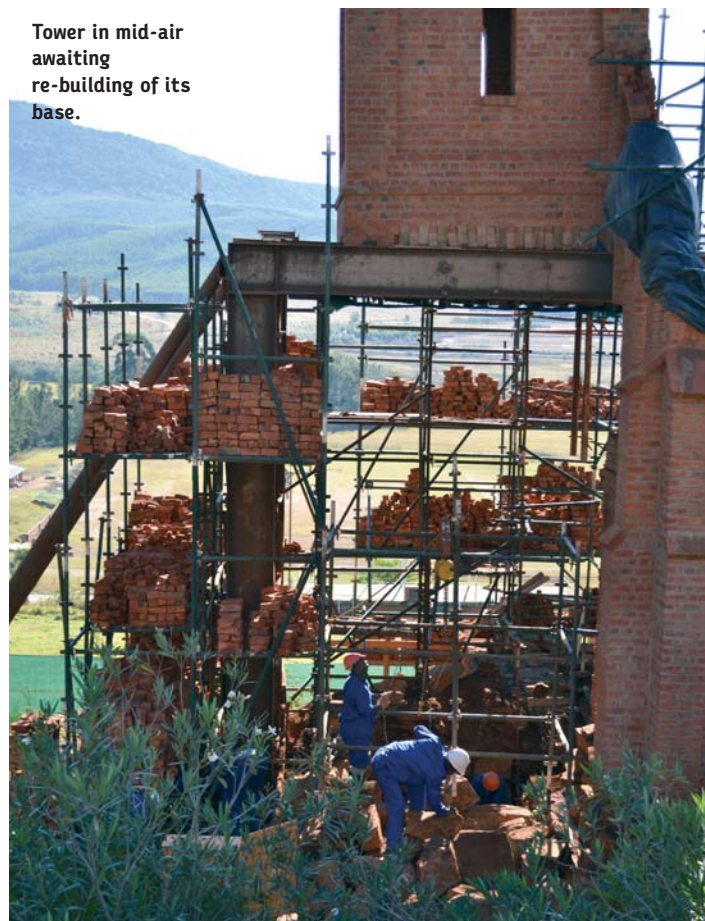
Tower in mid-air awaiting re-building of its base.

The irony of this particular church is that it was built without foundations which had led to cracking in the brickwork, the full extent of which was only revealed on excavation. The second issue was the repointing of the existing mortar joints which in itself is a laborious and time consuming task and should be done every 50 years with maintenance. The resulting building restoration will always be an issue of debate as the solutions are relative to each heritage architect's experience and preferences.

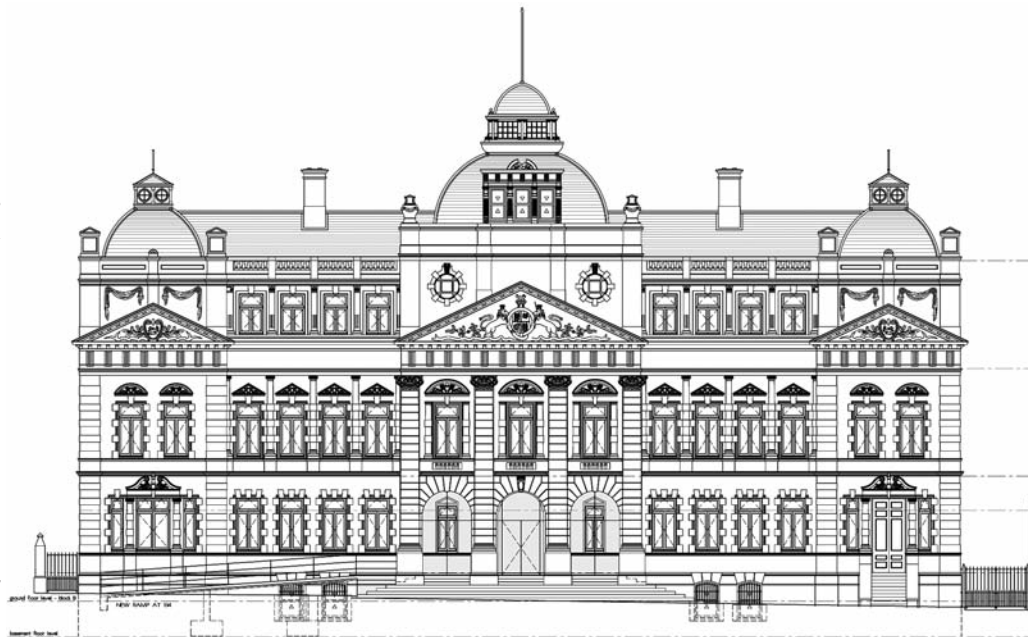
COLONIAL BUILDING

CHURCH STREET - SOUTH ELEVATION

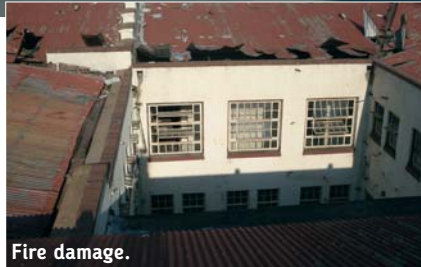
Fire damage.

Since the removal of the occupants in the 1980s, the building has stood empty. During this time the building was vandalized and sections burnt down. It was extensively damaged with its fittings removed, particularly the brass ones.

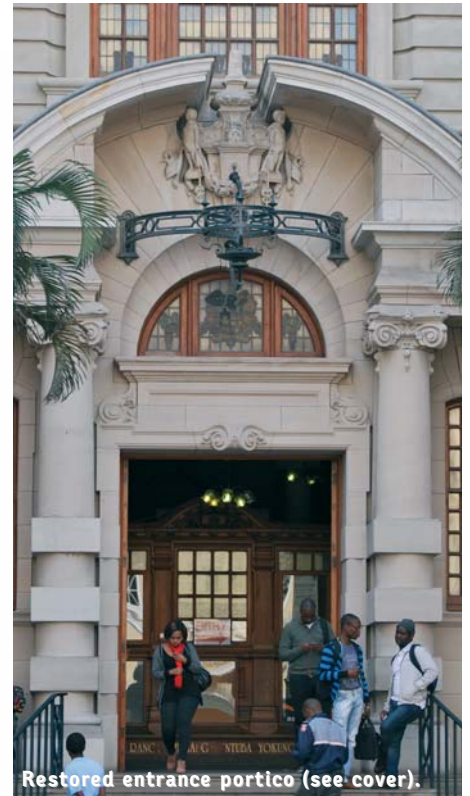
Restored entrance portico (see cover).

The sandstone restoration commenced on the north façade facing Dr Pixley Ka Seme (West) Street. On removal of the string course, the contractors cut back into the existing stone by 100mm and commenced replacement with new elements, counter-balanced and mechanically fixed with Grade 316 stainless steel straps and HPS and HSA anchors.

The majority of the string course volute mouldings were replaced and fixed with stainless

steel dowels. Delaminated ashlar blocks, column and window pilaster bases, column block and capitals were chopped out and exactly replaced in segments.

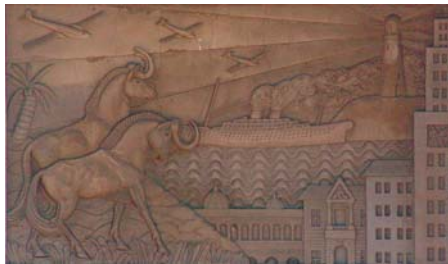
2. Province of Natal, Mural. Stucco panel in bas-relief in entrance portico.

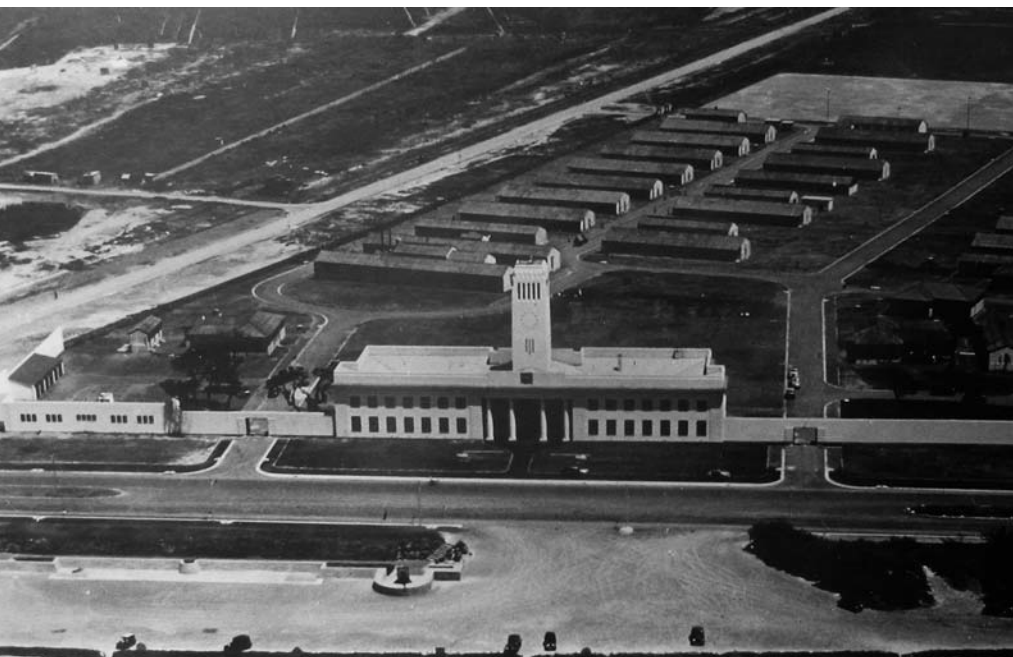
1. Natal Command, 1937. Demolition of the Central Tower was undertaken in WWII to avert U-boat surveillance.

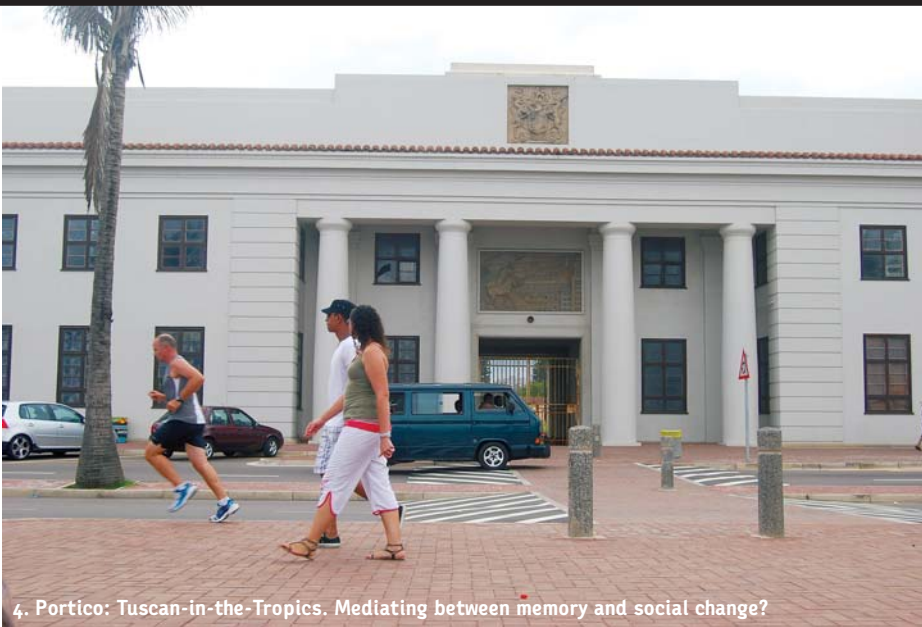
4. Portico: Tuscan-in-the-Tropics. Mediating between memory and social change?
